# Manhole Inspection Summary

Manhole # S31AA2018MH

Insp Date: **4/18/07 9:04 AM**

**Location** Address: **103 CROYDON RD**

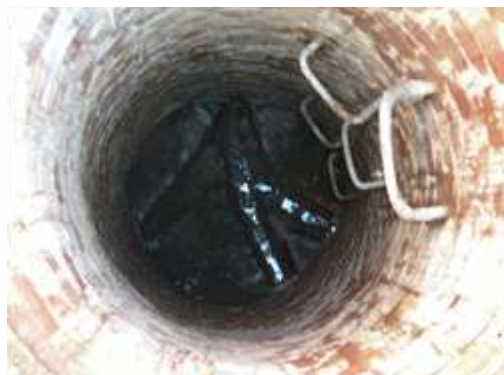
Top View

Evidence of surcharge - Bench debris.  
Channel debris.

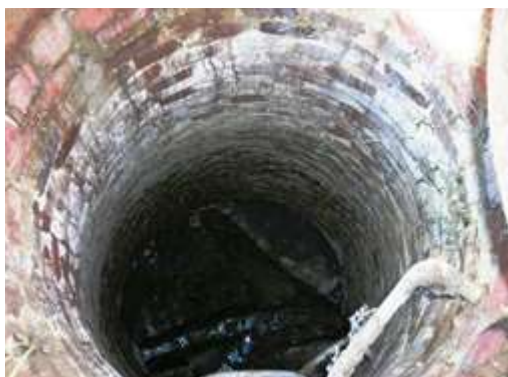
Defect

Adjustment and Corbel infiltration - other side.

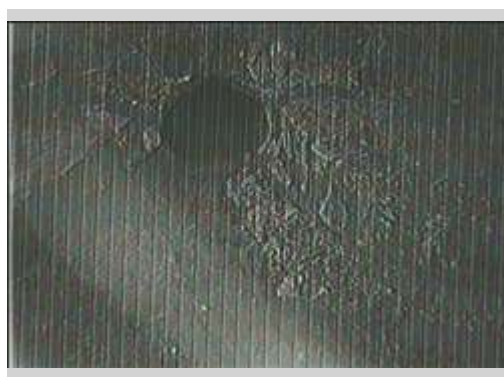
Defect

Channel root intrusion.

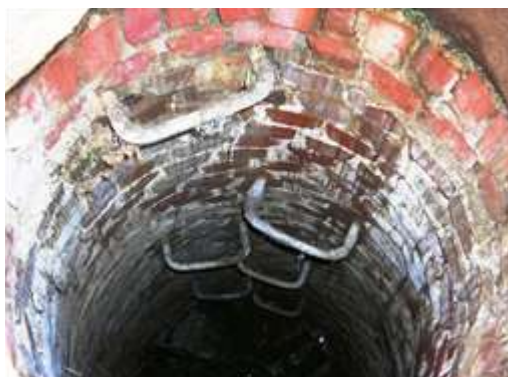
Defect

Adjustment deterioration and infiltration.  
Corbel infiltration.

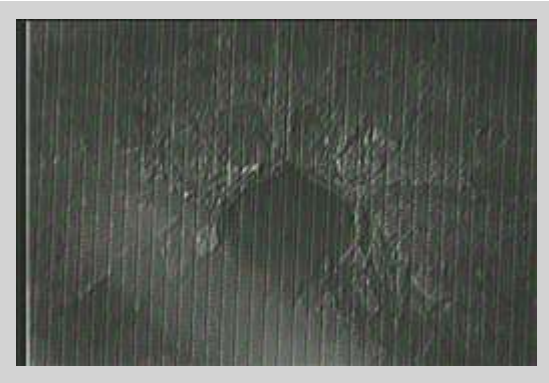
### 8 in. Circular Gravity Sewer Pipe Out @ 12 O'Clock

Barrel deterioration and infiltration.

Infiltration: **Evidence** Pipe Seal Cond: **Broken**

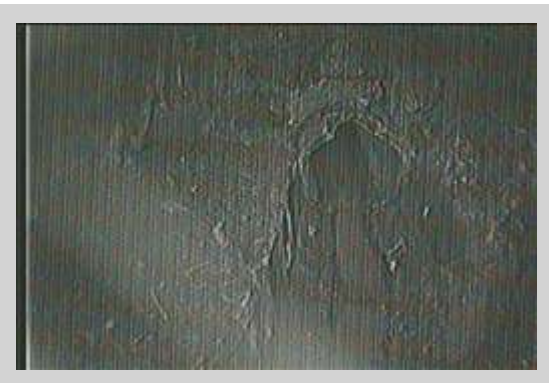
### 6 in. Circular Gravity Sewer Pipe In @ 4 O'Clock

Infiltration: **Evidence** Pipe Seal Cond: **Broken**

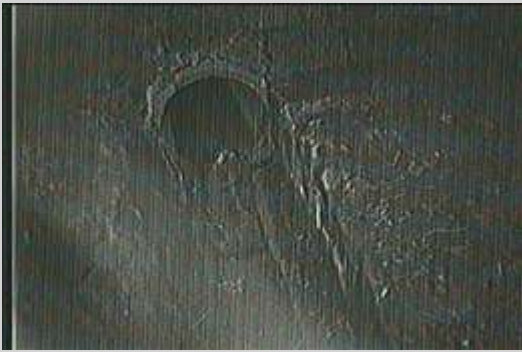
Pipe In @ 5 O'Clock

Channel deterioration.

Infiltration: **Evidence** Pipe Seal Cond: **Unknown**
